**Study on
Safety Issues of Rural Water way Crossings of Sri Lanka**

*By
Granie R Jayalath, Sri Lanka*

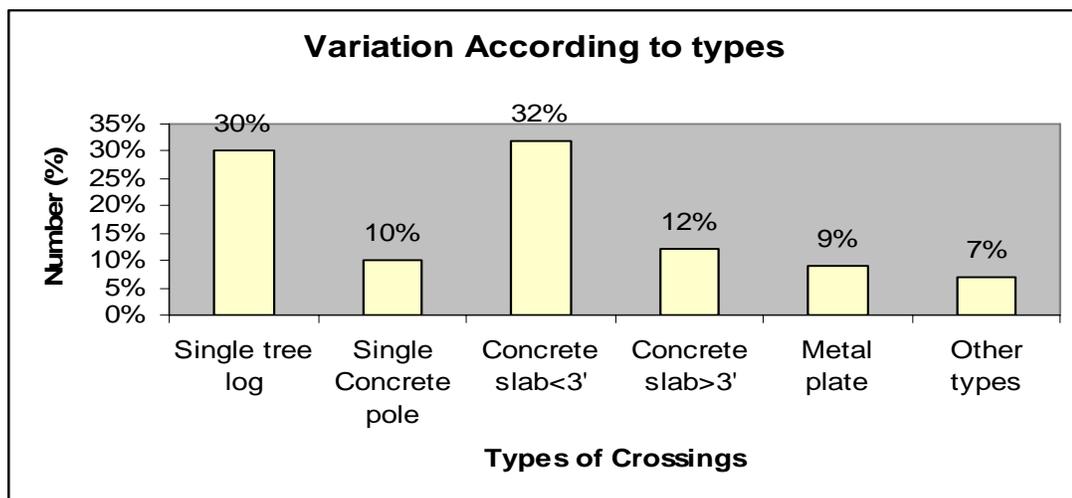
Fig: 2.0 Variations of Crossing Types

- a. 75% of these structures had a width $\leq 3'0'$ (approximately 0.91m)
- b. 12% of these structures had a width exceeding $6'0''$
- c. More than 92% of these structures do not have any sort of engineered abutments, instead railings, concrete beam, slab or tree trunks have been kept just over the cannel banks and these footings are continuously subjected to scouring and erosion. Hence almost all these structures are so vulnerable to collapse and need immediate attention to avoid possible catastrophic failures. Variation of crossing types as a % is depicted in fig 2.0.

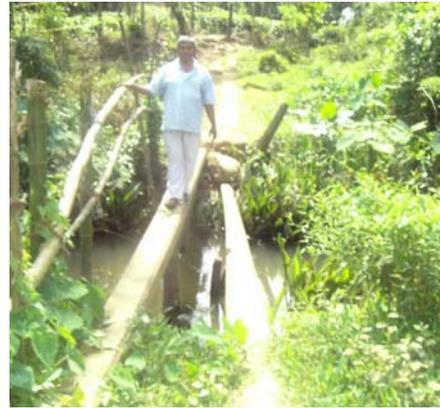
Fig: 3.0: Initially both poles were together at the same level

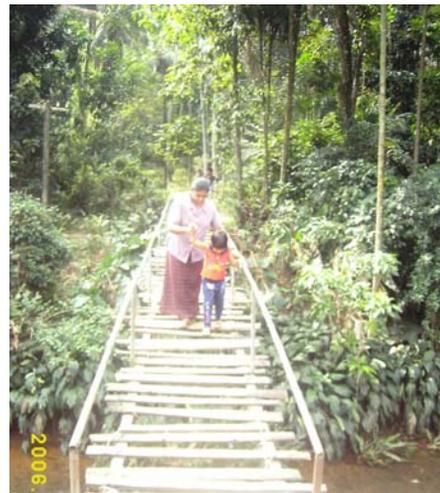
- h. About 12% of the families interviewed could be able to recall and described accidents occurred during their lifetime. Accordingly only 2 fatal accidents have occurred in Sabaragamuwa province whereas 16 droppings into cannels were recorded and 70% of these have been occurred during early night periods. Out of 16 droppings female count was 9.

Fig: 4.0: Majority of accidents were droppings through decks
